National Dam Inspection Program. Eberle  
Dam (NDI PA 036, PA-456), Susquehanna  
River Basin, Closes Creek, Tioga County,  
Pennsylvania. Phase I Inspection Report.

PHASE I REPORT  
National Dam Inspection Program

PA-456 Dam (Eberle Dam): NDS I.D. No. PA-00036

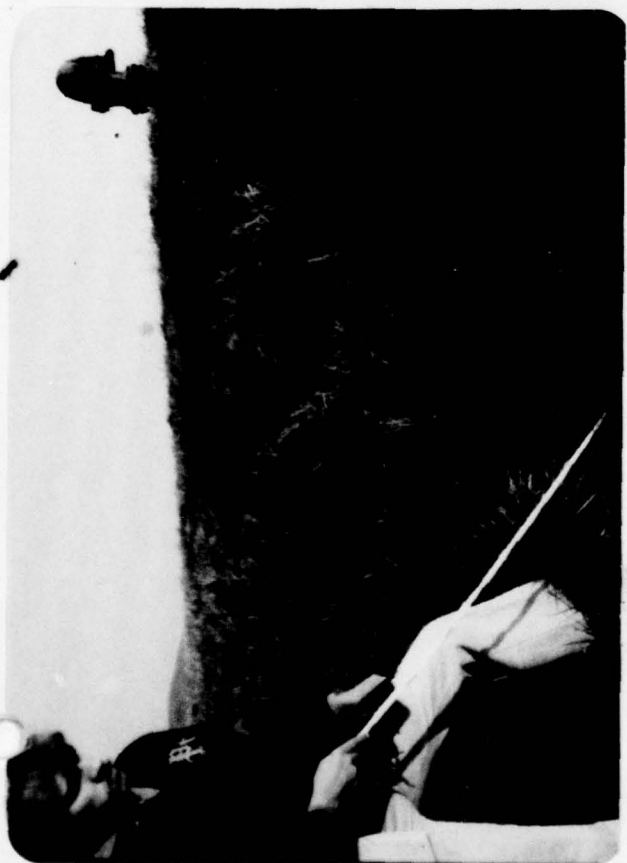
5

a) Service Spillway. The service spillway is a drop inlet type structure consisting of a reinforced concrete riser and a 30-inch diameter, reinforced concrete, discharge conduit. The riser is a 23-foot high structure and is located along the upstream toe between Stations 6+00 and 7+00. The intake orifice is two feet wide by one foot high and is set at elevation 1518.7 (see Figures 6 and 7 and Photograph 4). The riser unit is provided with an 8-inch diameter vent pipe which extends along the upstream slope of the embankment and rises to an elevation just above the crest of the dam (see Figure 6 and Photographs 2 and 5).

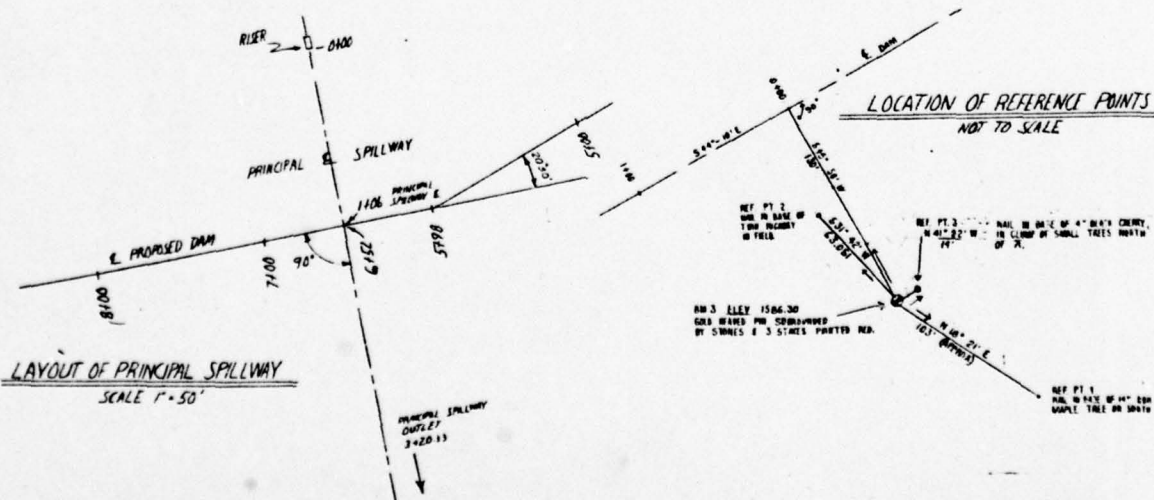
FIGURE 1 - PA-456 DAM  
GENERAL PLAN  
FIELD INSPECTION NOTES

b) Emergency Spillway. The emergency spillway is a trapezoidal channel cut into natural ground on the left abutment. The design provides for an earth dike along the right side of the spillway to direct the flow away from the embankment (see Figures 1 and 2, and Photograph 1); however, the effectiveness of this dike is questionable, based on field observations (see Figure 1 and Section 3.1.c.2).
